EXPERIENCE WITH THE USE OF DAPHNIATOXIMETER IN THE CZECH REPUBLIC

Premysl Soldan

Water Research Institute of T.G.M.
Ostrava Branch Office

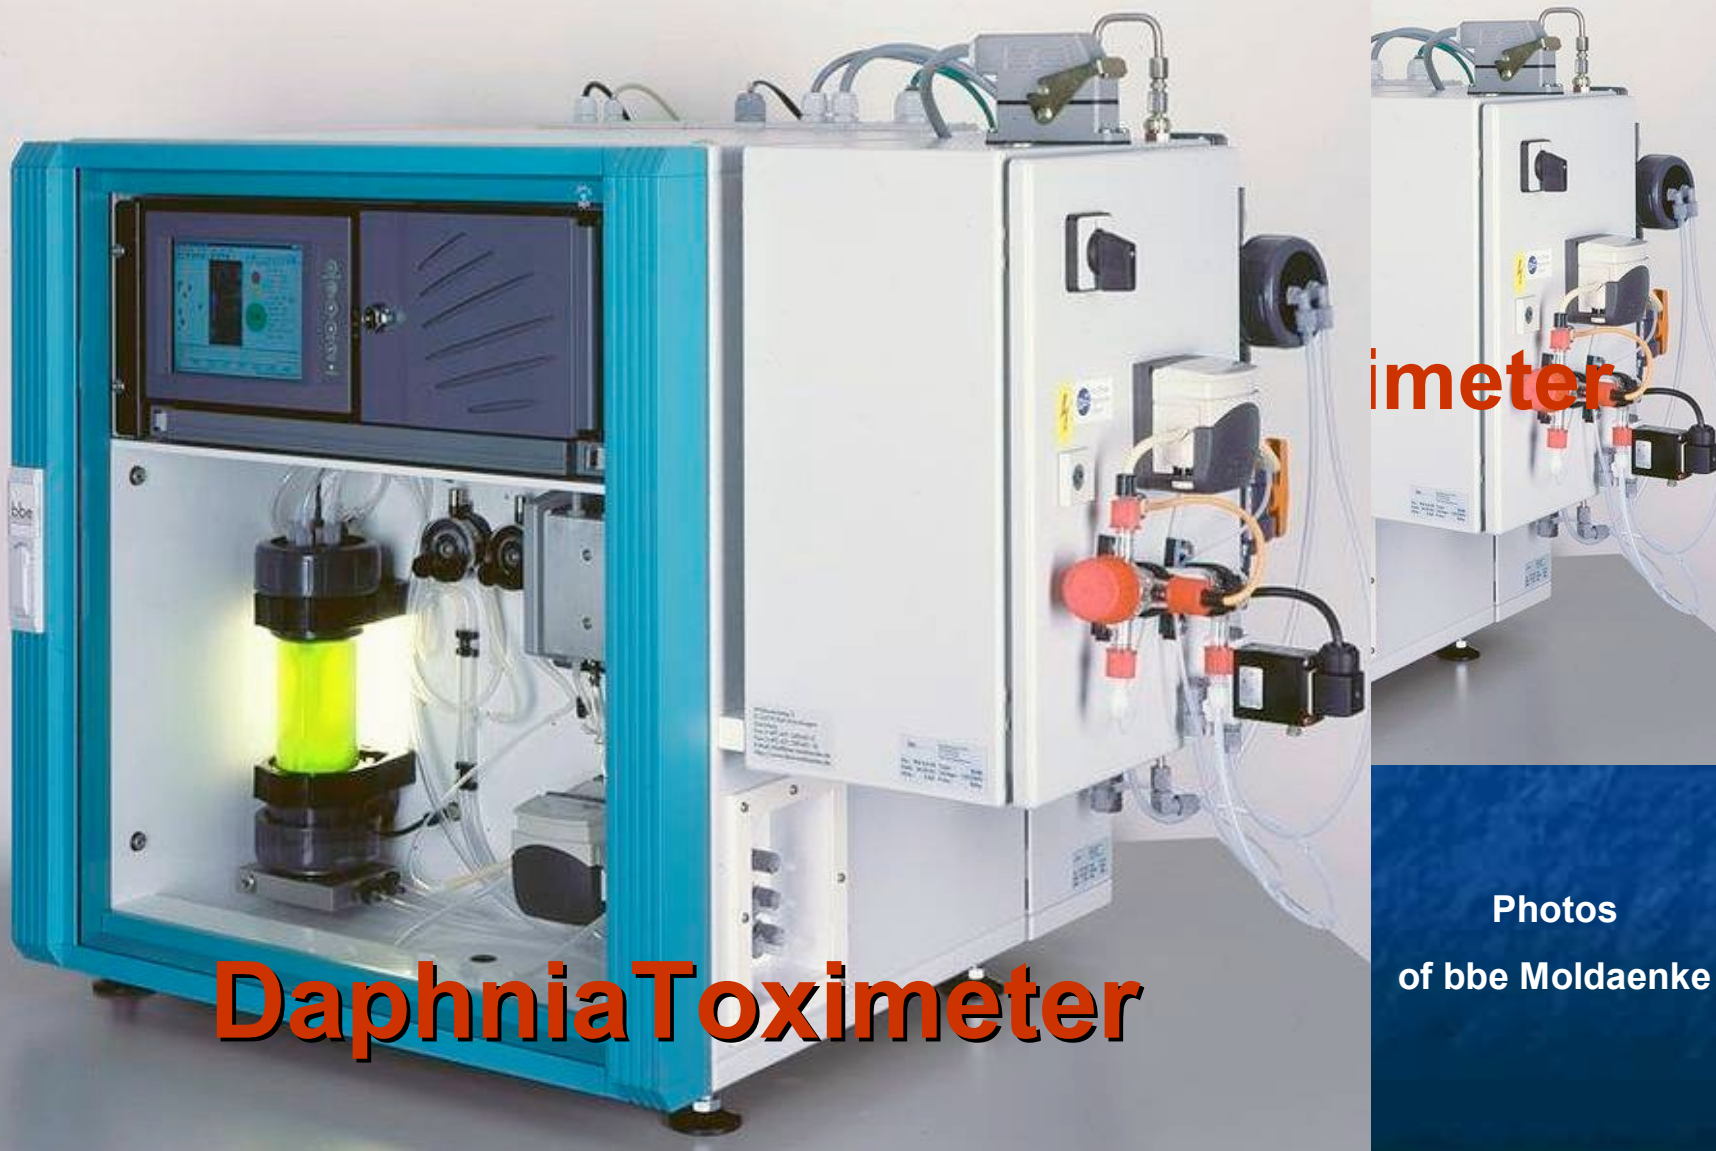
Daphnia Toximeter

Toximeter

Photos
of bbe Moldaenke

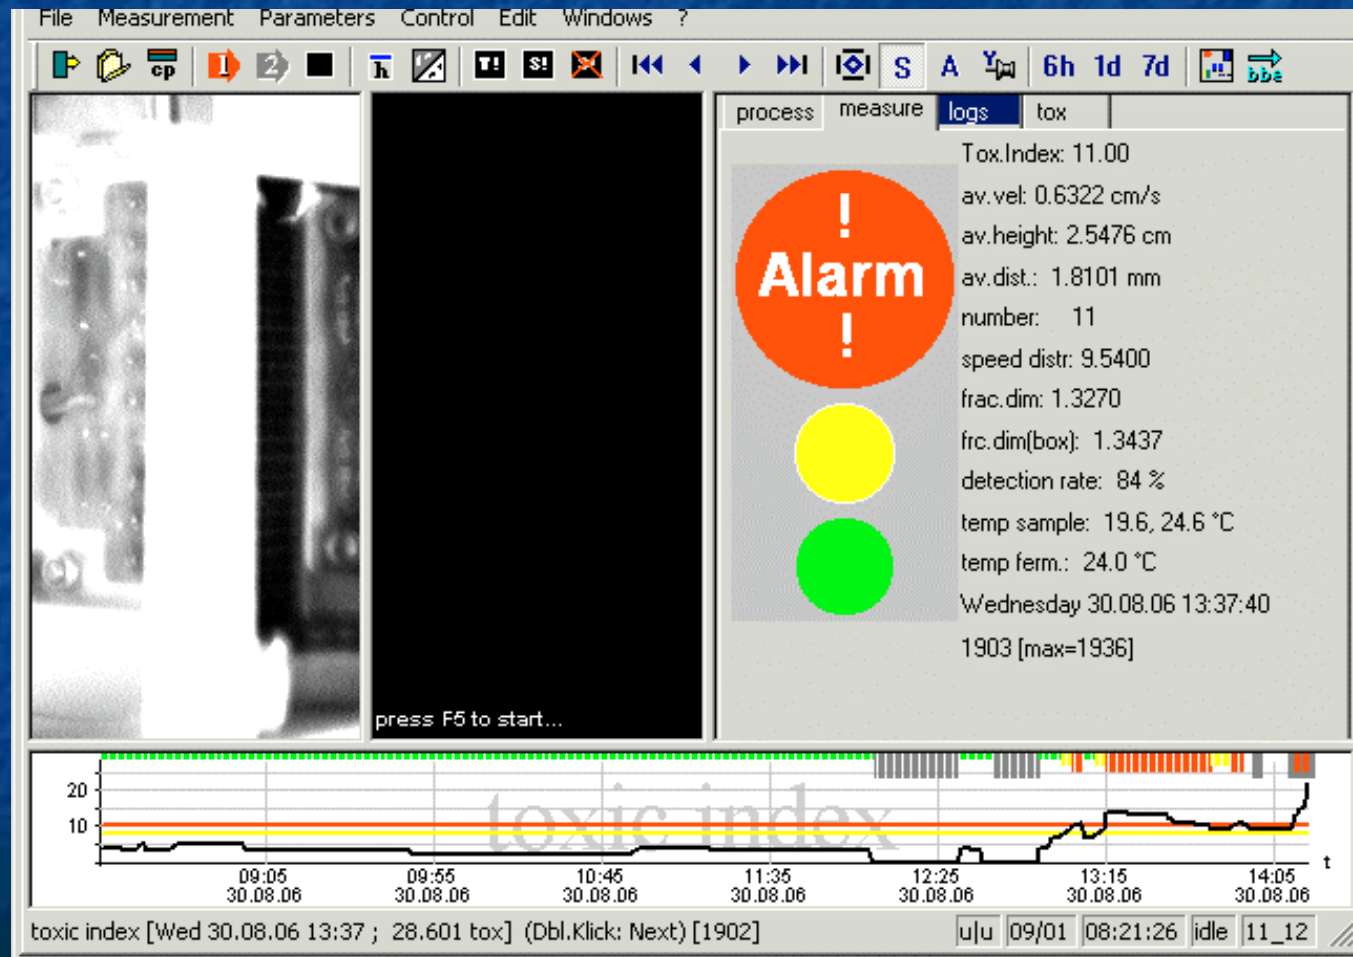
BorsodChem-MCHZ Accident

Accidental spill of benzenes from chemical works
BorsodChem-MCHZ Ostrava on 30.08.2006

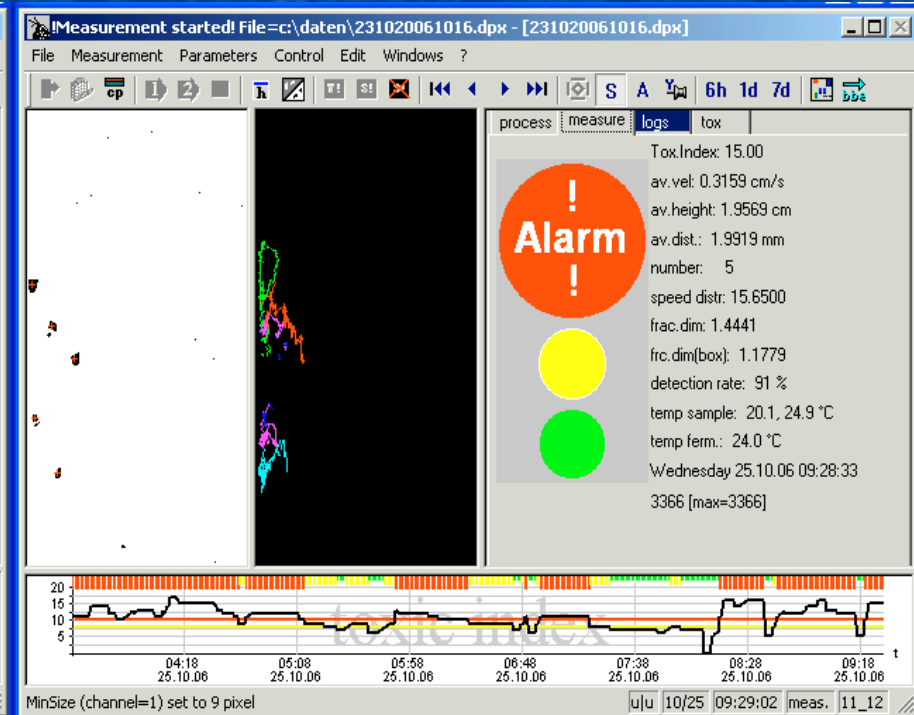
Fire at Hrusov II

Fire fighting and rain drainage impact

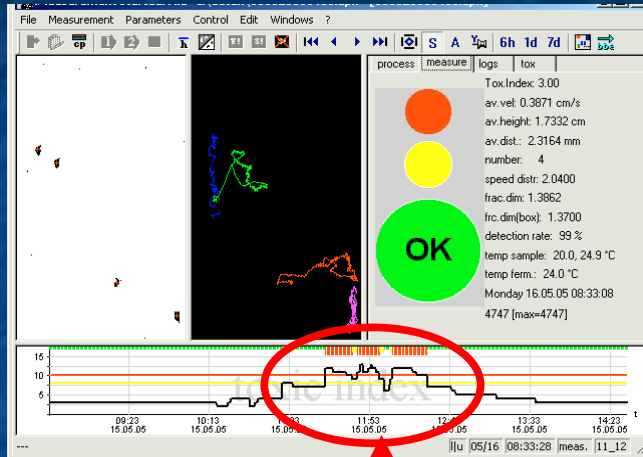
alarm 15.05.05 (SUN) 11,30 – 12,30 hod

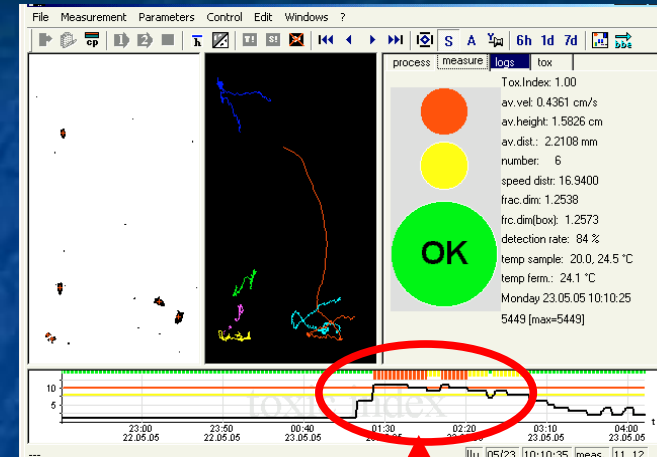
alarm 22.05.05 (SUN) 1,20 – 2,20 hod

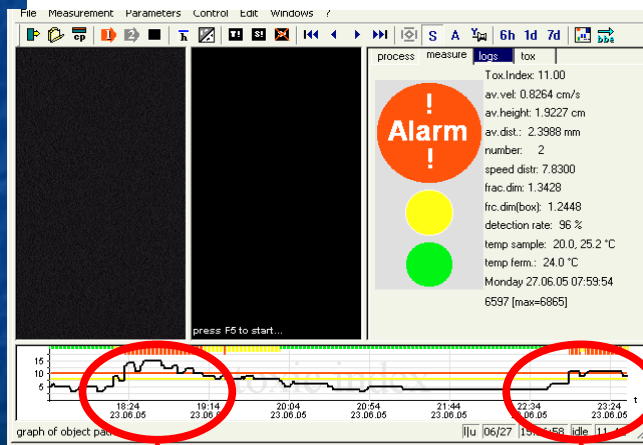
alarm 23.06.05 (SAT) 18,10 – 19,10 a 23,00 – 23,30 hod

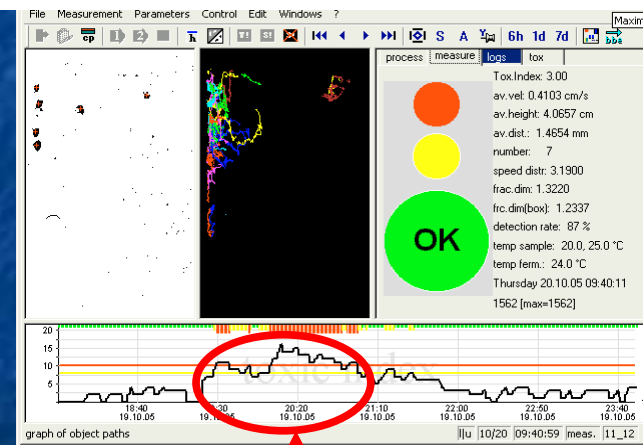
alarm 19.10.05 (WEN) 19,30 – 21,00 hod
